Home Inspection Ride-Along Project

Jeff B.

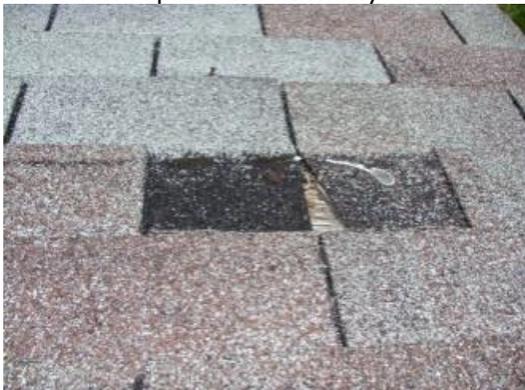
Roof Gable: The roof decking is exposed just below the ridge on the back side of the roof. The area has been repaired and many of the shingles are loose.

Recommend repairs by a fully qualified licensed contractor.

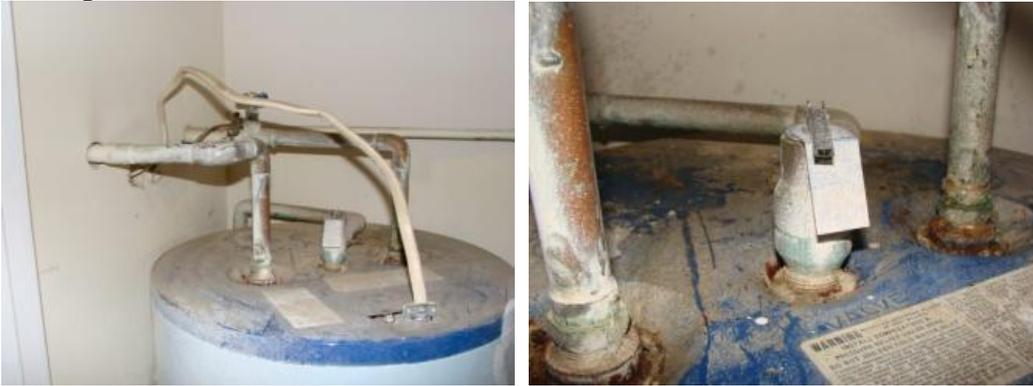
Plumbing Water Heater: (safety Hazard/Explosion) The temperature, pressure and relief valve drain termination was not located. Hot water came out of the top of the valve when it was tested. The temperature of the water is hotter than 120 degrees. Lower the temperature by adjusting the heating elements.

The end of the pipe may be underground somewhere around the perimeter of the house. Locate the pipe and remove any soil that may be lodged in the pipe.

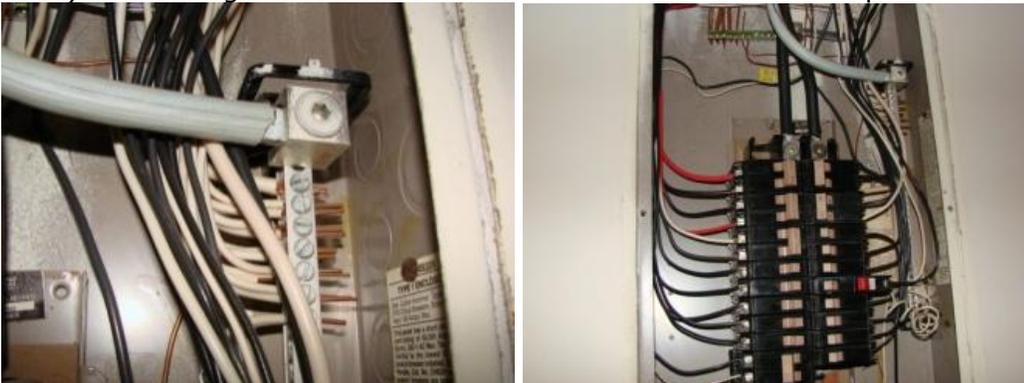
Electrical Wiring Notes: (Safety Hazard/Shock/Fire) 1). More than one grounded conductor (neutral wires) are sharing the same terminal set screws inside the main panel located in the laundry room.

2). The well pump 12 gauge conductors are over-fused and enter a 30 amp double pole circuit breaker inside the main panel.

Recommend repairs by a fully qualified licensed electrical contractor.

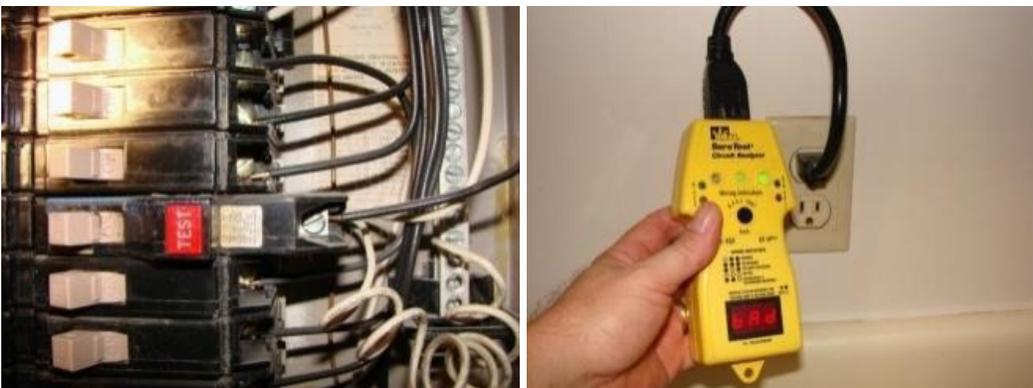
3). The ground fault circuit breaker in the main panel is defective. It failed to trip when tested. Ground fault protection is missing on all kitchen countertop outlets.

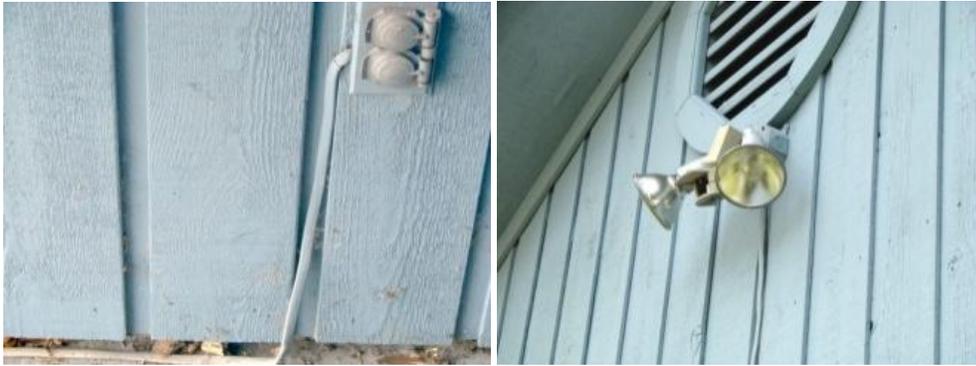
4). All exterior floor light non metallic cable is exposed and unprotected from physical damage. The conductors are improperly wired into light fixtures and outlets.

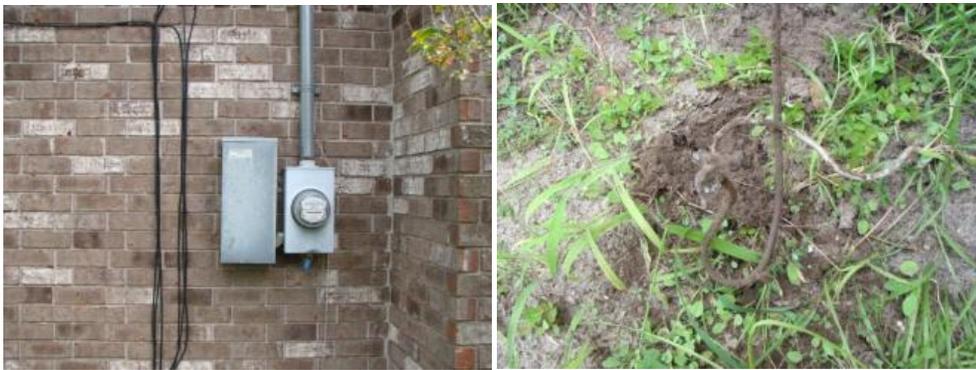
5). The grounding conductor is disconnected from the rod below the utility meter. FYI use a direct buried rated bronze acorn ground clamp to secure the conductor to the rod.

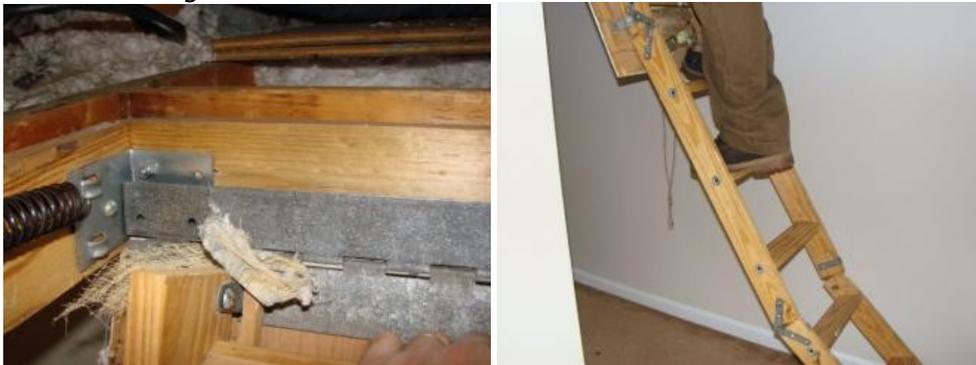
Attic: (Safety Hazard/Fall) The access fold down steps are unsafe. The frame and steps are damaged. The stairs are not fully secured to the ceiling framing. Hot air is leaking into the hallway and is entering the air handler return.

Recommend a fully qualified contractor install a new access stairs with insulation.

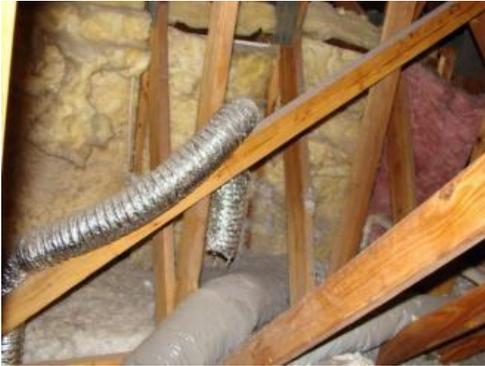
Laundry: (Safety Hazard/Fall) The dryer flexible vent duct terminates inside the attic near the air handler. The insulation and ducts are covered in lint.

Recommend a fully qualified licensed contractor replace the flexible duct with smooth metal ducts and terminate the ducts up through the roof inside a damper type dryer vent hood with out screens.
